Chapter 8 Specialized Repairs

8-1. Lock Wall Rehabilitation

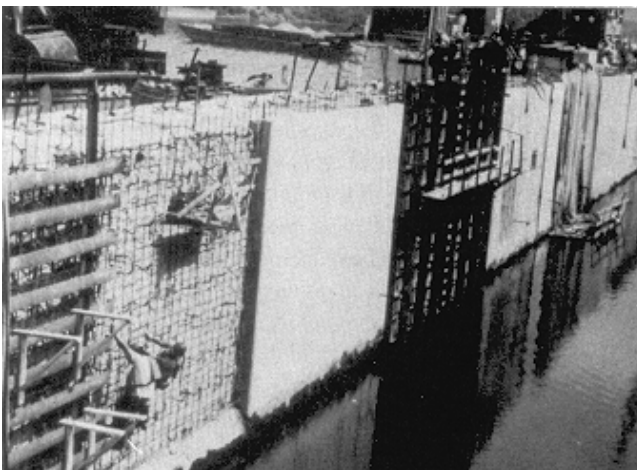
Figure 8-1. Placing reinforcing steel and horizontal armor prior to concrete placement, Locks and Dam No. 3, Monogahela River

(3) Reinforcement. Mats of reinforcing steel, usually No. 5 or 6 bars on 305-mm (12-in.) centers each way, are hung vertically on the dowels (Figure 8-1). Concrete cover over the reinforcing is usually 100 or 127 mm (4 or 5 in.). In some cases, the reinforcing mat, wall armor, and other lock wall appurtenances are installed on the form prior to positioning the form on the face of the lock wall (Figure 8-2).

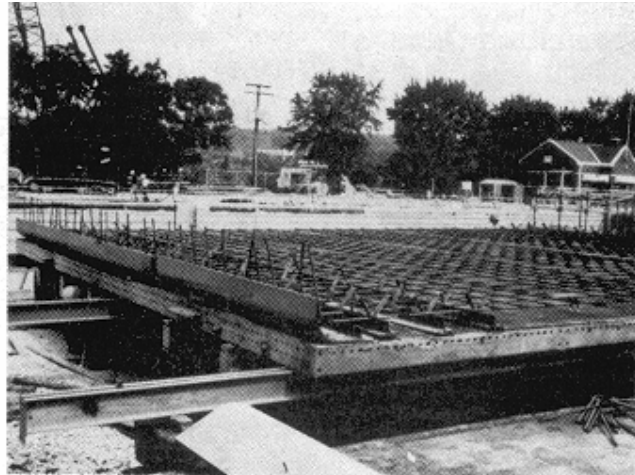
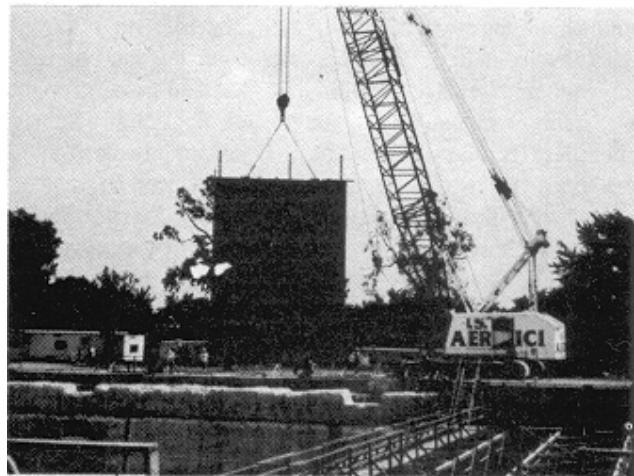
Figure 8-2. Lock wall rehabilitation, Brandon Rock Lock

a. Wall armor and concrete reinforcement in place on the form

b. Concrete forming being placed in position on the lock wall

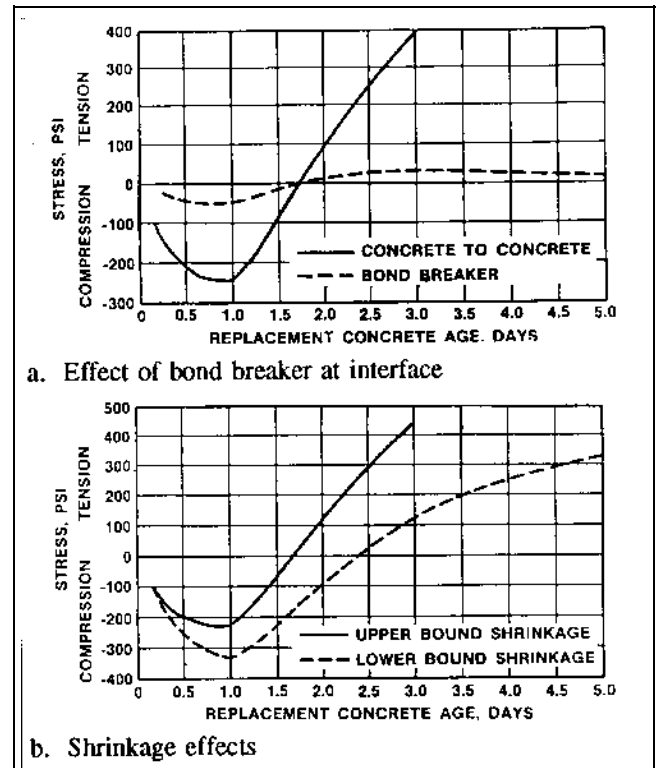
(a) A finite element analysis of a typical lock wall resurfacing (Norman, Campbell, and Garner 1988) also demonstrated the effect of restraint by the existing concrete. Under normal conditions of good bond between the two concretes, stress levels sufficient to cause cracking in the replacement concrete developed within about 3 days (Figure 8-4a). In comparison, a bond breaker at the interface resulted in almost no stress in the replacement concrete. The analysis also indicated that shrinkage was a significant factor (Figure 8-4b). Even the lower bound shrinkage resulted in tensile stresses in excess of 2.1 MPa (300 psi).

Figure 8-4. Results of a finite element analysis of a typical lock wall resurfacing

(b) CEWES-SC recommendations to minimize shrinkage and install a bond breaker (Hammons, Garner, and Smith 1989) were implemented by the U.S. Army Engineer District, Pittsburgh, during the rehabilitation of Dashields Locks, Ohio River. An examination of the project indicated that cracking of concrete placed during 1989 was significantly less than that of concrete placed during the previous construction season prior to implementation of CEWES-SC recommendations. Also, resurfacing of the lock walls at Lock and Dam 20, Mississippi River, resulted in significantly less cracking in the conventional concrete than was previously experienced at other rehabilitation projects within the U.S. Army Engineer District, Rock Island. The reduced cracking was attributed to a combination of factors including lower cement content, larger maximum size coarse aggregate, lower placing and curing temperatures, smaller volumes of placement, and close attention to curing (Wickersham 1987). Preformed horizontal contraction joints 1.5 m (5 ft) on center were effective in controlling horizontal cracking in the rehabilitation of Lock No. 1, Mississippi River (McDonald 1987b).

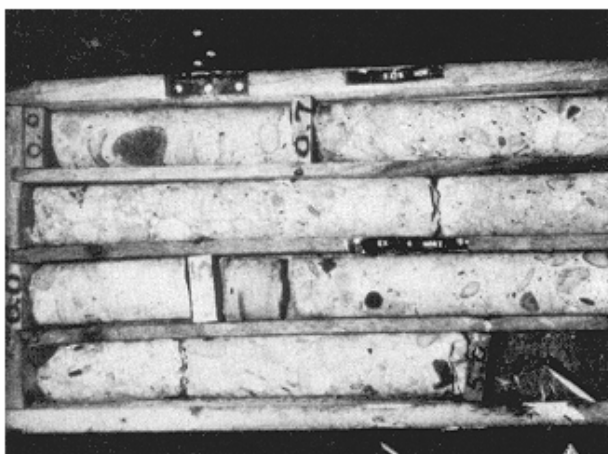
Figure 8-6. Comparison of cores taken horizontally from lock chamber walls, Emsworth Locks

b. Portions of the core from two drill holes through land chamber wall which was not refaced

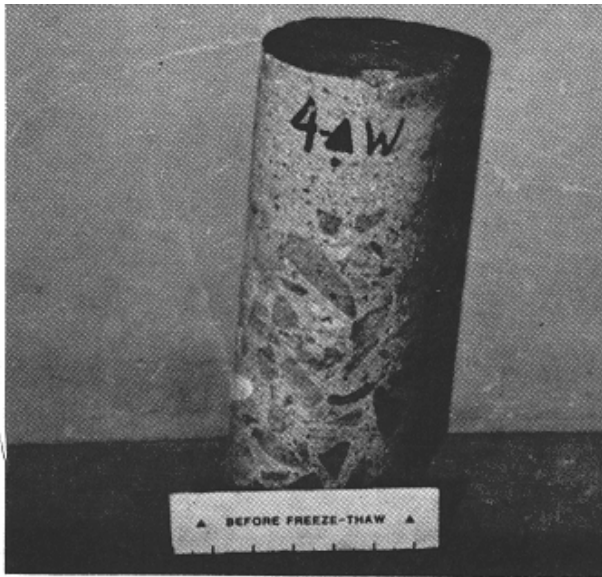
Figure 8-8. Combination shotcrete and concrete core before and after 35 cycles of freezing and thawing in a saturated condition

a. Before freezing and thawing

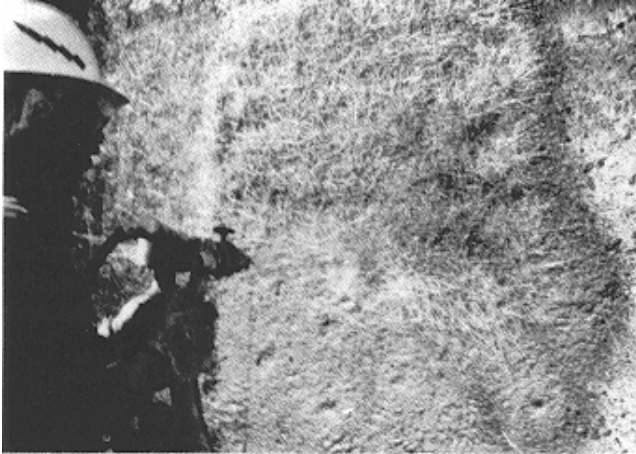
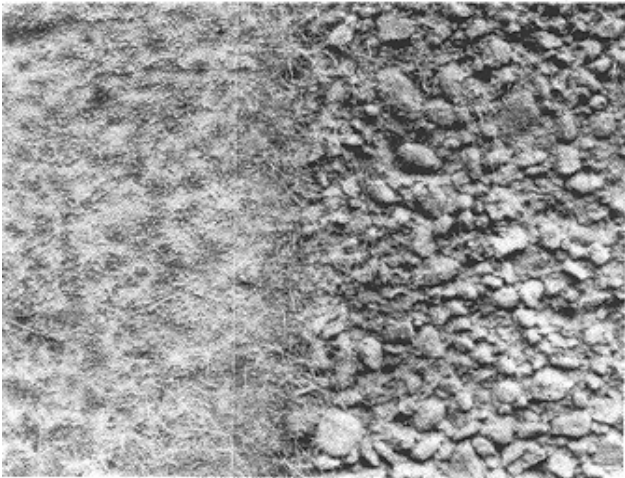
Figure 8-10. Application of coating to lock wall, Lower Monumental Lock

a. Applying the coating with equipment that simultaneously sprays the mortar from one nozzle while it chops and blows the fiber from a cutterhead

b. Typical appearance of the lock wall before and after repair

be in generally good condition. However, the coatings applied earlier in 1983 had all failed after only 6 months in service. The major difference in the two repairs was the type of latex used. Saran was used in the original work, whereas styrene butadiene was used in the repairs which failed. It was also reported that delaminations were common where latex spray-up material had been applied over hardened latex from a previous coating. One possibility for this failure is that the high-pressure water jet did not properly clean the surface of latex film prior to application of the subsequent layer. After approximately 5 years in service, large pieces of the spray-up coating began to fall from the lock walls. Failure occurred in the

concrete substrate immediately behind the bond line. Moisture migrating toward the surface from within the mass concrete was trapped at the interface because of the low water vapor transmission characteristics of the coating. Subsequent ice and hydraulic pressure caused the coating to debond (Schrader 1992).

(d) The concrete in the walls of Lower Monumental Lock has an inadequate air-void system to resist damage caused by freezing and thawing while critically saturated. After approximately 10 years in service, the concrete had deteriorated to the point that the aggregate was exposed. After laboratory tests and a full-scale field test which demonstrated that a 10-mm (3/8-in.)-thick latex-modified fiberglass-reinforced spray-up coating had the potential to meet repair requirements, which included time constraints on the lock downtime that precluded conventional concrete replacement (Schrader 1981), the lock walls were repaired (Figure 8-10) in 1980. In March 1983 several small isolated areas of debonded coating (less than 1 percent of the total area) were identified in the lock. The coating in these locations was removed and the areas resprayed similar to the original repair. Also, a fairly large debonded zone in monolith 11 was repaired. A September 1983 inspection reported the original coating to

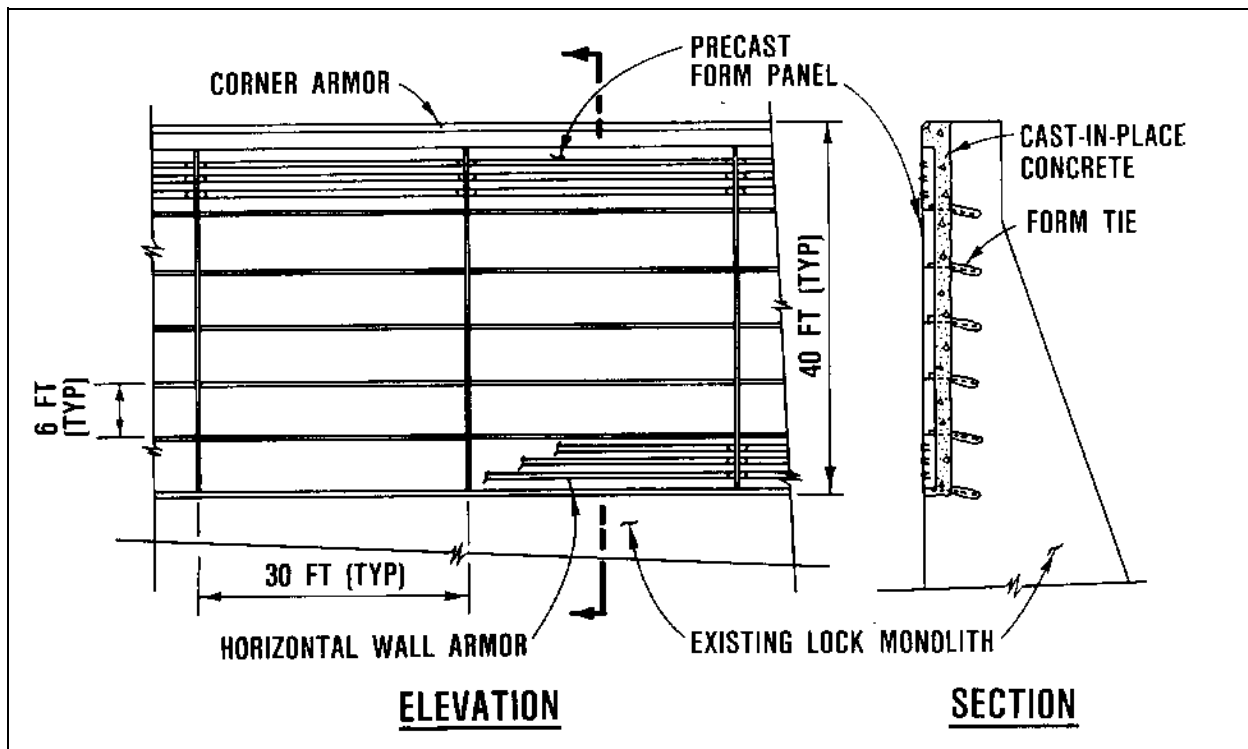
Figure 8-12. Precast concrete stay-in-place forming system for lock wall rehabilitation

(a) A wide range of alternatives for achieving the design objectives was evaluated through a process of value engineering (ABAM Engineers 1987a). Based on this analysis, it was concluded that the most advantageous combination of design alternatives was a precast-quality concrete (minimum compressive strength of 45 MPa (6,500 psi)), conventionally reinforced, flat panel, horizontally oriented and tied to the lock wall (Figure 8-12). A typical panel was 165 mm (6-1/2 in.) thick, 1.8 m (6 ft) wide, 9.1 m (30 ft) long, and it weighed approximately 7 tons. The panels are tied to the lock monolith along the top and bottom edges with form ties designed to support the loads of the infill concrete placement.

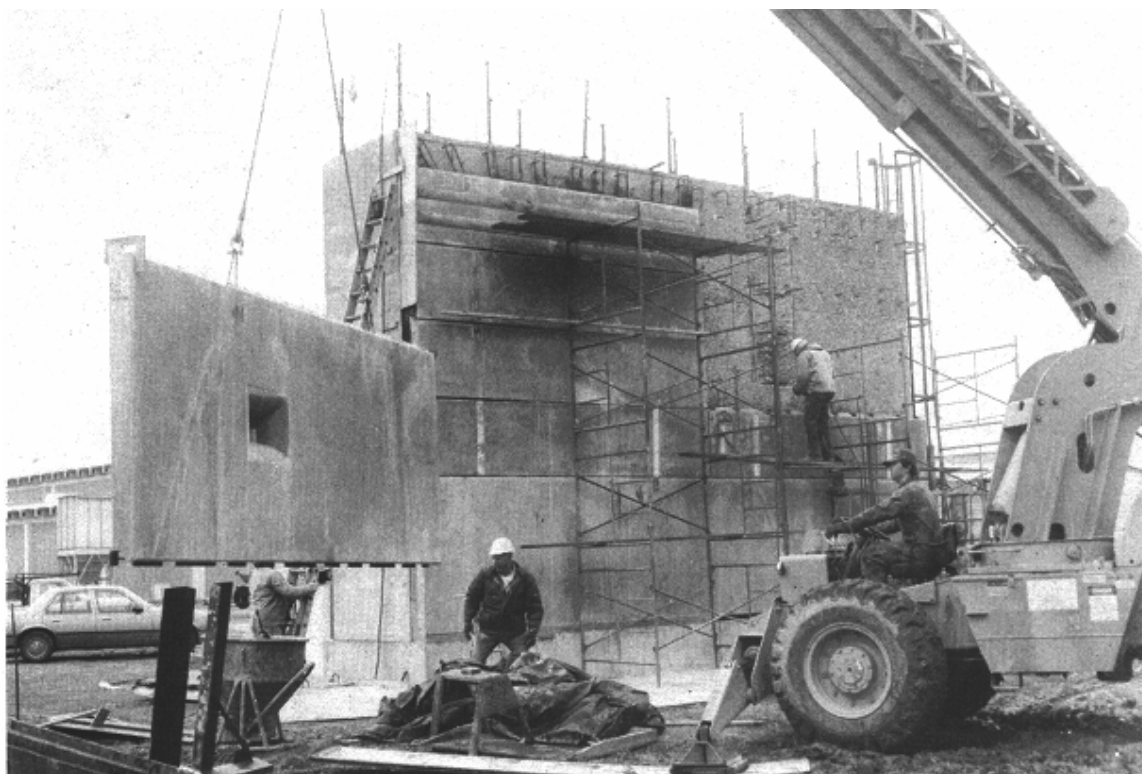
Figure 8-13. Demonstrating the constructibility of the precast concrete stay-in-place forming system

(b) To demonstrate the constructibility of the system, eight panels of varying sizes were precast and installed on two one-half-scale simulated lock monoliths (Figure 8-13). The purpose of the demonstration was to evaluate the feasibility of the precast concrete stay-in-place forming system without the risk and investment of undertaking a full-scale lock rehabilitation. Results of this work demonstrated that the precast concrete stay-in-place forming system is a viable method for lock wall rehabilitation (ABAM Engineers 1987b). In addition to providing a concrete surface of superior durability with minimal cracking, the construction cost was very competitive with the cost of conventional cast-in-place concrete. The demonstration also identified a number of areas where the design and installation procedures could be enhanced thus reducing both the cost and schedule associated with the stay-in-place forming system. Development of the precast concrete stay-in-place forming system is summarized in a video report (McDonald 1988) which is available on loan from the CEWES Library.

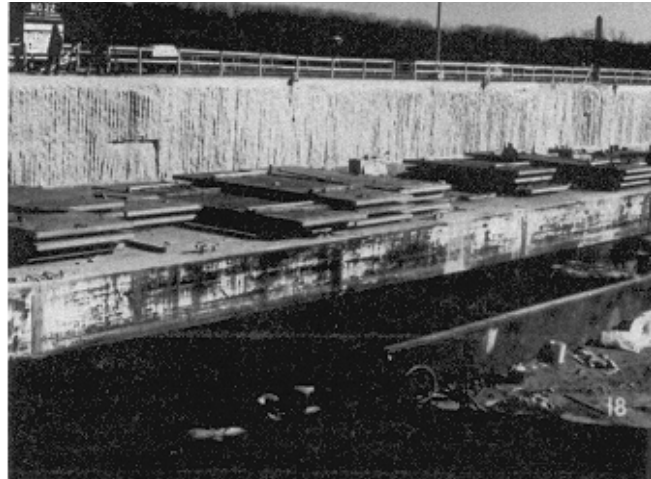
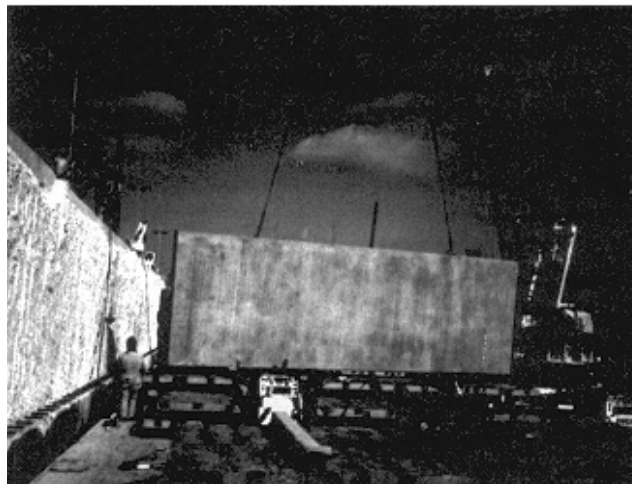
Figure 8-14. Installation of precast concrete stay-in-place forms at Lock 22, Mississippi River

(c) The panels were transported to the site by river barges and lifted into position with a barge-mounted crane (Figure 8-14). The panels were held on the sawcut ledge while they were leveled with the vertical alignment hardware and the bottom panel anchors were welded to the weld plates embedded in the panels. The top panel anchors were then installed and welded to the embedded weld plates. Each panel was aligned and welded in 2 to 3 hr. The space between the panels and lock wall was filled with nonshrink cementitious grout. Approximately 1,070 sq m (11,500 sq ft) of the lock walls were resurfaced. The bid price for the precast panel repair, including concrete removal, was \$980 per sq m (\$91 per sq ft). Bid prices for this initial application of the precast concrete stay-in-place forming system for lock wall rehabilitation were somewhat higher than anticipated. However, the rehabilitation went very smoothly, despite severe winter weather conditions, and the precast panels were installed in about one-half the time that would have been required for cast-in-place concrete.

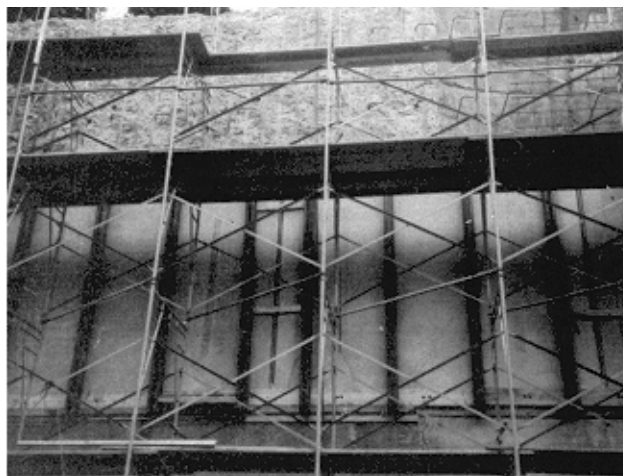
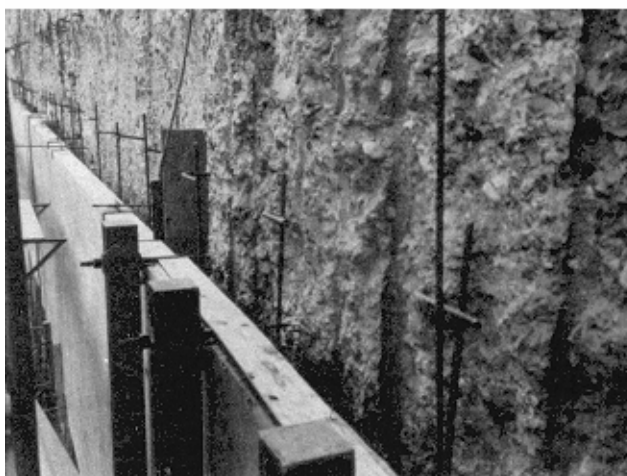
Figure 8-15. Installation of precast concrete stay-in-place forms at Troy Lock, Hudson River (Miles 1993)

(h) A minimum of 305 mm (12 in.) of concrete was removed from the lock walls by saw cutting around the perimeter of the removal area, line drilling, and explosive blasting. Following air-jet cleaning of the surface, anchors were grouted into holes drilled into the existing concrete. These bent reinforcing bar anchors were located to line up with the hoop anchors embedded in the precast panels. The majority of the panels were installed during the winter of 1991-92 when ambient temperatures were generally cold, at times reaching -18 °C (0 °F). The precast panels were lifted from delivery trucks with a crane and lowered onto steel shims placed on the sawcut ledge. The panels were positioned with temporary holding and adjustment brackets, shebolt form anchors at the top and bottom of the panels at 1.2-m (4-ft) spacings, and steel strongbacks spanning between the shebolts. Once the panels were positioned and aligned, vertical reinforcing bars were manually installed from the top down to intersect the panel and wall anchors (Figure 8-15). Once the bars were properly located, they were tied to the anchors to prevent misalignment during placement of the infill concrete.

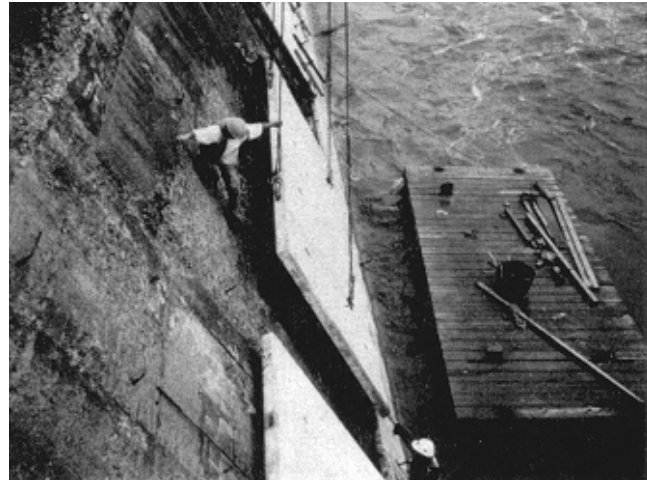
Figure 8-17. Installing precast concrete panels used to overlay the back side of the river wall at Troy Lock, Hudson River (Miles 1993)

(k) In addition to resurfacing the lock chamber, precast concrete panels were used to overlay the back side of the river wall at Troy Lock (Figure 8-17). Original plans for repair of this area required extensive removal of deteriorated concrete and replacement with shotcrete. This repair, which would have had to be accomplished in the dry, would have required construction of an expensive cofferdam to dewater the area. Therefore, it was decided that concrete removal could be minimized and the need for a cofferdam eliminated if this area was repaired with precast concrete panels. Three rows of precast panels were used in the overlay. The panels were installed in 1992 while the lock was in operation. The bottom row of panels was partially submerged during installation and

infill concrete placement. An antiwashout admixture allowed the infill concrete to be effectively placed underwater without a tremie seal having to be maintained. The application of precast concrete in this repair resulted in an estimated savings of approximately \$500,000 compared to the original repair method. Also, the durability of the aesthetically pleasing precast concrete should be far superior to shotcrete which has a generally poor performance record in repair of lock walls.

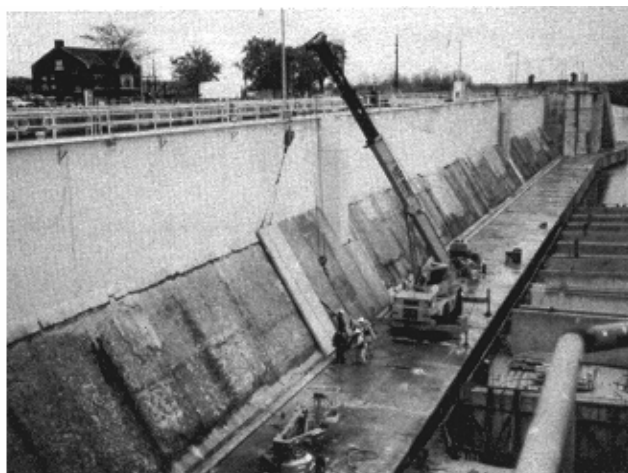
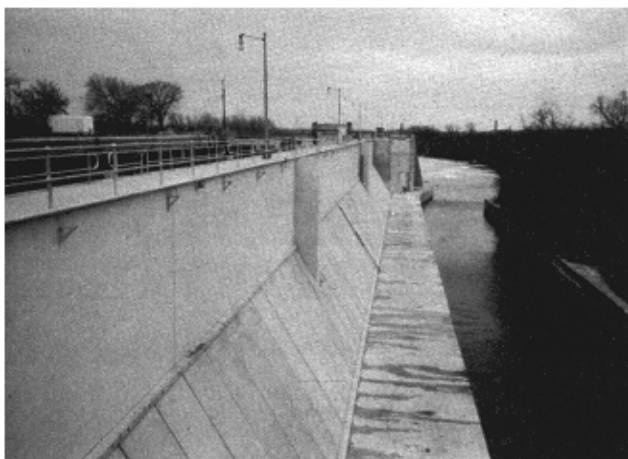
Figure 8-18. Backside of river wall, Lockport Lock, Illinois Waterway

a. Installation of precast concrete panels

b. River wall complete with precast concrete panels

(l) Precast concrete panels were also used to overlay the lower, battered section of the backside of the river wall at Lockport Lock, Illinois Waterway (Figure 8-18). Before the panels were placed, the concrete surface was cleaned of all loose concrete with a high-pressure water jet. Then the precast concrete base was positioned and anchored along the horizontal surface at the base of the wall. In addition to conventional reinforcement in each direction, the precast panels were prestressed vertically. Embedded items included weld plates at the bottom of the panels and steel angles with embedded bolts at the top of the panels. Typical panels were 152 mm (6 in.) thick, 7.1 m (23.2 ft) high, and 2.3 m (7.5 ft) wide.

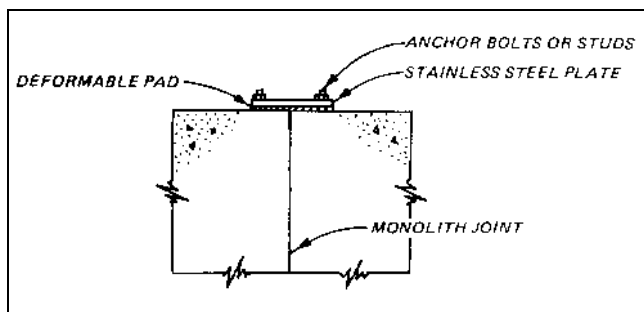
Figure 8-19. Typical plate type waterstop

moisture trapped behind the plate; and (5) hardening of the flexible pad due to aging (Schrader 1980).

a. Surface plates. A plate-type surface waterstop (Figure 8-19) consists of a rigid plate, generally stainless steel, spanning the joint with a neoprene or deformable rubber backing. The plate is attached with anchors which provide an initial pressure on the deformable pad. Water pressure against the plate provides additional pressure so that the deeper the waterstop is in a reservoir, the tighter the plate presses to the surface of the joint. This type waterstop has had varying degrees of success. At John Day Lock, it has worked relatively well but at Lower Monumental Lock, it has not performed satisfactorily. The major difference between these structures is that at Lower Monumental, the joint movement is more than that at John Day. Potential problems with this type of repair include: (1) loosening of the anchor bolts; (2) reverse hydrostatic pressure from water trapped behind the waterstop when the reservoir drops; (3) mechanical abuse such as a barge tearing off the plate; (4) ice pressure from

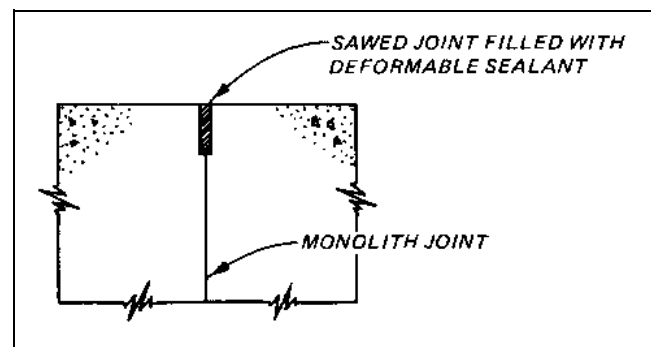
Figure 8-20. Typical sawed joint filled with sealant

b. Caulked joints. When the reservoir level can be dropped below the elevation to which repairs are necessary, and if the joint opening is not too great, a simple and economical repair may be possible by saw cutting along the joint on the positive pressure, or reservoir side, and then filling the cut with an elastic sealant (Figure 8-20). The sawcut should be wide enough to span the joint and cut about 3 mm (1/8 in.) minimum into the concrete on each side of it. The cut must also be deep enough to penetrate any unsound, cracked, or deteriorated materials. Typically, a cut 13 mm (1/2 in.) wide by 38 mm (1-1/2 in.) deep is acceptable. The cut should follow the joint to its base; otherwise, water migrating underneath the sealant can build up pressure in the joint behind the sealant. To perform satisfactorily, the sealant must set rapidly, bond to cool and damp concrete, and remain flexible under anticipated service conditions, and it must not sag in vertical applications or extrude through the joint under hydrostatic pressure. Once problems of partial extrusion due to inadequate curing were solved, this type of repair exhibited reasonable success for several years at Lower Monumental and Little Goose Locks.

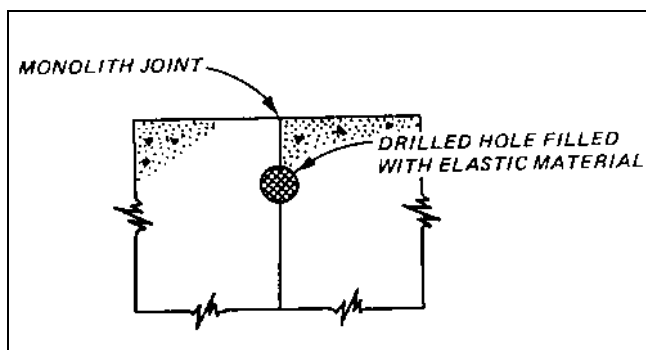
Figure 8-21. Drilled hole with elastic filler

c. Drill holes filled with elastic material. This approach (Figure 8-21) consists of drilling a large-diameter hole from the top of the monolith along the joint and into the foundation, and filling the hole with an elastic material. Typically, the hole is 76 to 152 mm (3 to 6 in.) in diameter and drilled by a "down-the-hole" hammer or core drill. The more costly core drilling allows easy visual inspection of hole alignment along the joint, but the down-the-hole hammer has proven to be the preferred method of drilling. Small underwater video cameras can also be used to inspect hole alignment and condition of the joint.

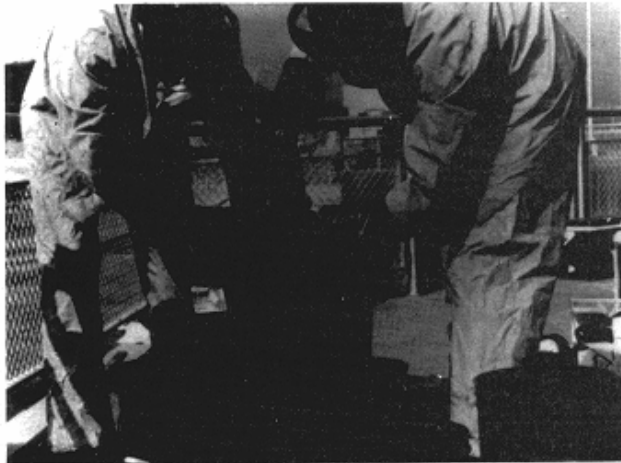
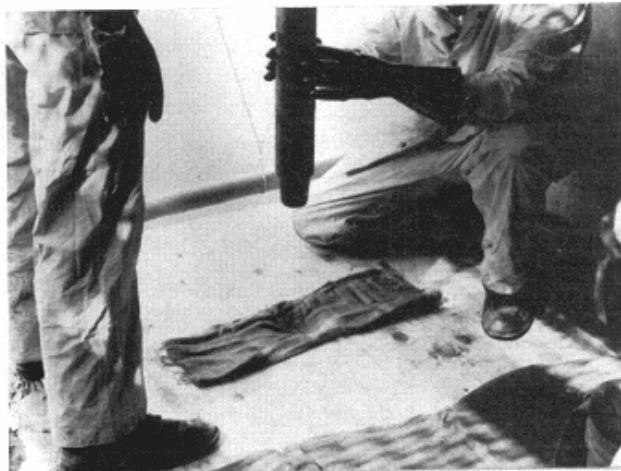
Figure 8-22. Remedial waterstop installation, Dardanelle Lock

a. Saturating burlap bags with chemical grout

b. Saturated bag on top of drill hole awaiting insertion

(b) Water-activated urethane foam grout systems have also been used as elastic fillers. These hydraulic polymers are activated when placed in contact with water and upon curing form a tough, flexible gel approximately 10 times its original volume. One approach in using these materials is to stuff burlap bags which have been saturated with the grout into the drill holes (Figure 8-22). Water in the drill holes activates the grout system causing the grout to expand and completely fill the holes. Tamping the bags as they are pushed into the holes with drill stem will force some of the grout into the joints prior to gel formation. Gel times will vary with ambient and water temperatures but generally can be controlled with additives to be in the range of 5 to 10 min. This procedure was used at Dardanelle Lock with a reduction in gallery leakage of approximately 95 percent. Technical representatives for the material manufacturers should be contacted for detailed guidance on specific grout systems.

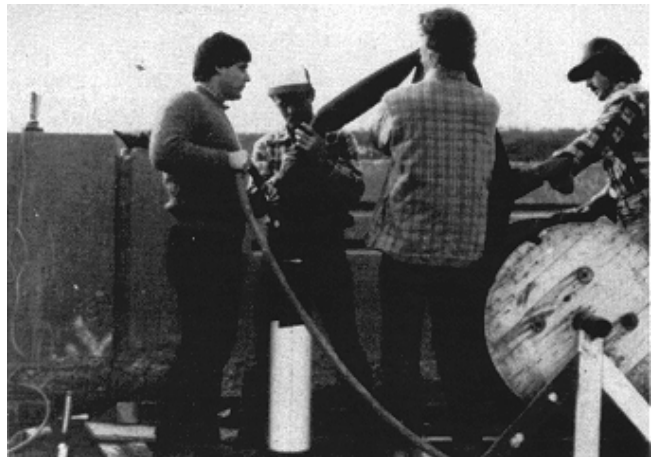
Figure 8-23. Two-component natural rubber and elastomer coated nylon sleeve being inserted into drill hole, Bagnell Dam

(2) Liner materials. In some cases, a continuous tube-type liner has been inserted into the drill hole (Figure 8-23) to contain the filler material. Liner materials include reinforced plastic firehose, natural rubber, elastomer coated fabric, neoprene, synthetic rubber, and felt tubes. In most cases, the liners are not bonded to the walls at the drill holes and rely on differential pressure between the interior of the liner and the external water level to force the liner against the sides of the hole. Obviously, any type of liner material should be of sufficient flexibility to allow the tube to conform to any voids and irregularities in the surface of the drill hole and to accommodate differential movement between adjacent monoliths.

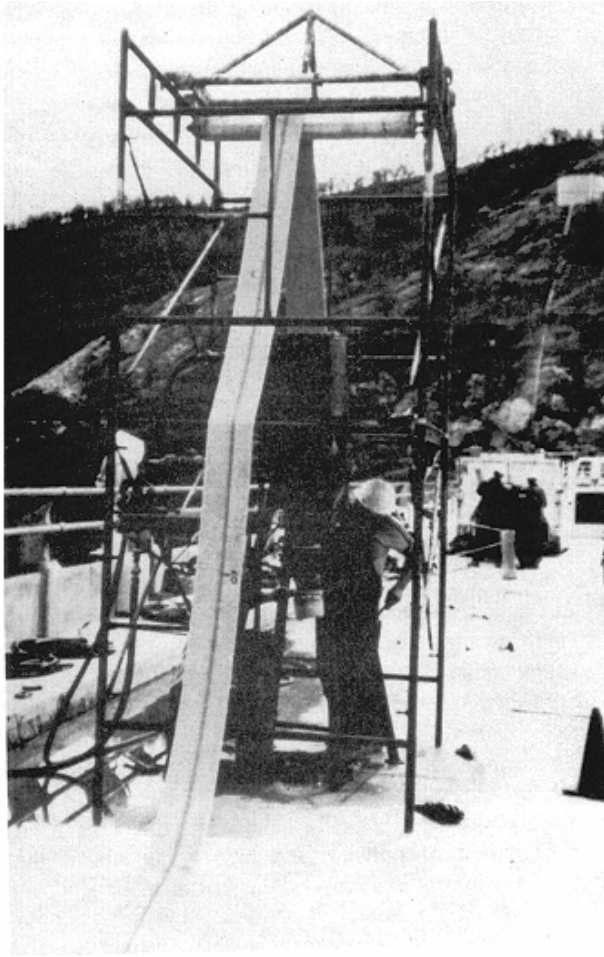
Figure 8-24. Inversion apparatus for installing tube in drill hole, Pine Flat Dam

bonding of the liner to the surface of the drill hole. In this procedure, the liner is fabricated from thin polyurethane film with an under layer of felt approximately 6 mm (1/4 in.) thick. Prior to installation, water-activated polyurethane resin is poured into the tube to saturate the felt lining. The resin is distributed evenly throughout the tube by passing it through a set of pinch rollers. The tube is then inserted into the drill hole, and as it is inserted water pressure is used to turn the tube inside-out (Figure 8-24). When the inversion process is complete, the resin-impregnated felt is in contact with the surface of

the drill hole (Figure 8-25). Water inside the drill hole activates the resin grout creating a bond between the liner and the drill hole. This procedure was used to repair three leaking joints at Pine Flat Dam in March 1985. The drill holes ranged in depth from 58 to 78 m (189 to 257 ft) with a combined flow of 515 L/min (136 gal/min). After repair, the flow dropped to 45 L/min (12 gal/min). As a result of the excellent performance of these repairs, the same procedure was used in 1993 to correct leakage through additional monolith joints at Pine Flat Dam.

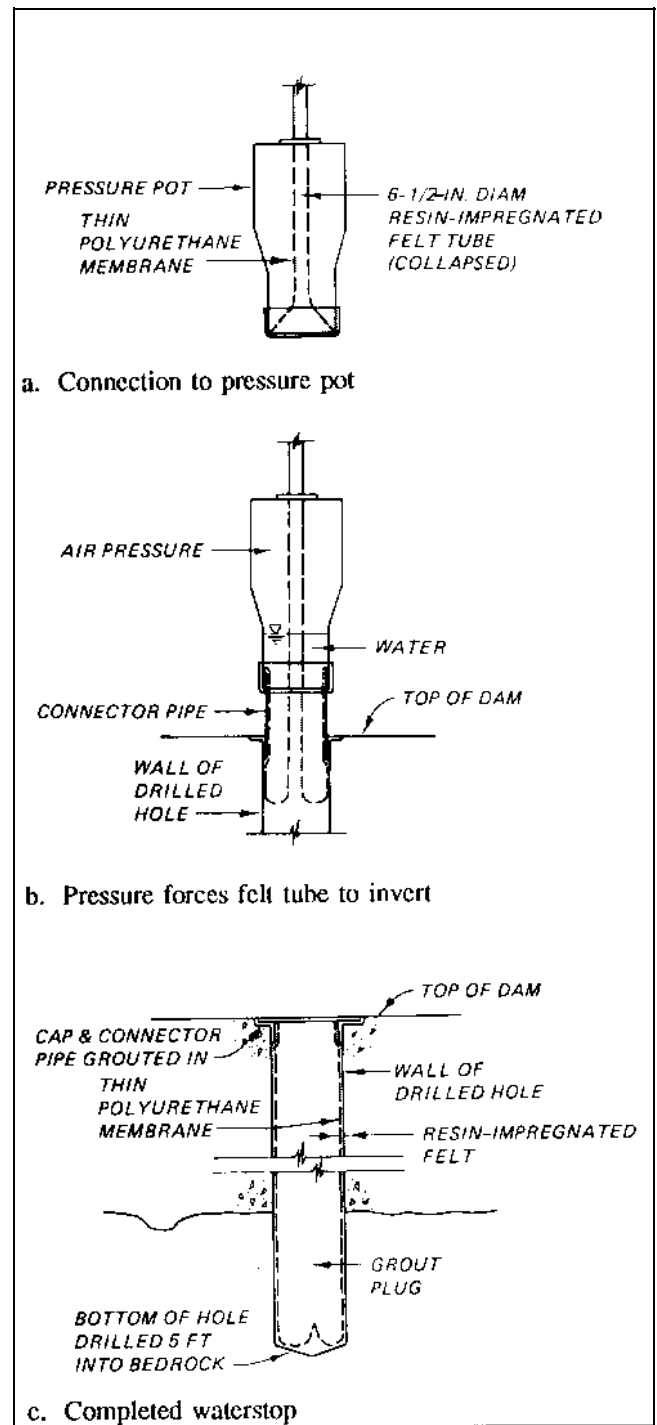
Figure 8-25. Remedial waterstop installation, Pine Flat Dam

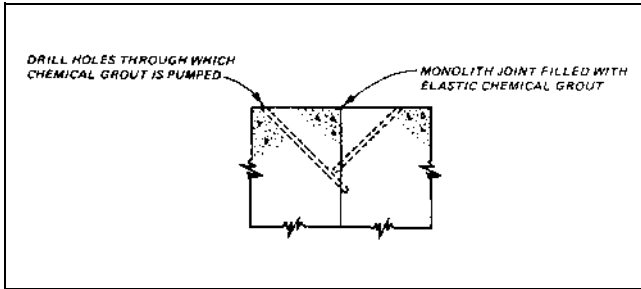
joint behind the waterstop (Figure 8-26). An elastic chemical grout is then injected through the drill hole. Criteria for the injection grout require that it have low

Figure 8-26. Joint filled with elastic grout through injection

viscosity, gel or set quickly, bond to wet surfaces, be suitable for underwater injection, possess good elastic strength, and tolerate unavoidable debris. Water-activated polyurethane injection resins generally meet the desired criteria. Gel times for these materials are normally in the range of 5 to 60 sec which is usually adequate for low-flow conditions. Large-volume or high-pressure flows must be controlled during grout injection and curing. Materials and methods commonly used to control such flows include lead wool hammered into the joint, foam rubber, or strips of other absorbent materials soaked in water-activated polyurethane and packed into the joint, oakum packed into the joint, and small-diameter pipes embedded in the packing material to relieve pressure and divert flow. If the joint opening is greater than approximately 2.5 mm (0.1 in.), a surface plate waterstop may be necessary within the gallery or conduit to prevent grout extrusion with time because of hydraulic pressure along the joint.

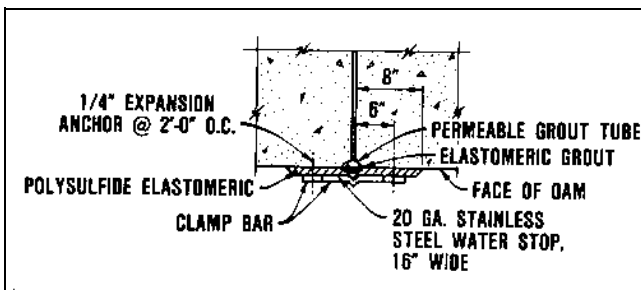
(2) Exterior joints. A combination of grouted joint and surface plate waterstop techniques was used to seal vertical contraction joints on the upstream face of the Richard B. Russell Dam (Figure 8-27). A permeable grout tube was placed in the vertical vee along the face of each joint and covered with an elastomeric sealant. After

Figure 8-27. Combination grouted joint and surface plate-type waterstop, Richard B. Russell Dam

the sealant hardened, the grout tube was injected with a polysulfide sealant to fill the joints from the dam face into the embedded waterstop. The polysulfide sealant was also placed on the face of the dam for a distance of 203 mm (8 in.) on either side of the joints. Prior to hardening of the sealant, a surface plate waterstop of 20-gauge stainless steel was anchored into position over the joint.

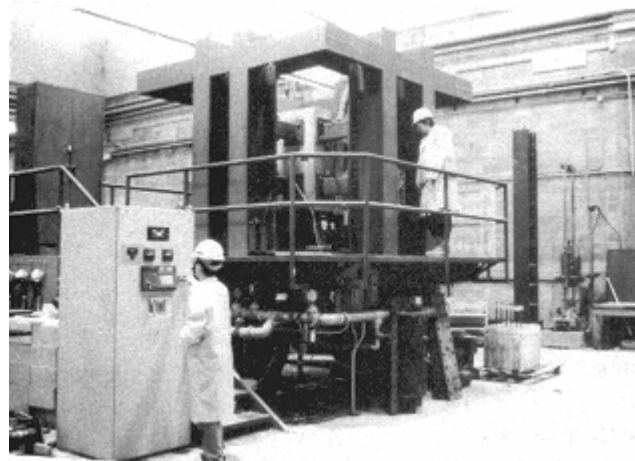
e. Summary. Because of a lack of appropriate test methods and equipment, most of the materials and procedures described have been used in prototype repairs with limited or no laboratory evaluation of their effectiveness in the particular application. Consequently, a test apparatus was designed and constructed, as part of the REMR research program, to allow systematic evaluation of waterstop repair techniques prior to application in prototype structures. The apparatus consists of two concrete blocks, one fixed and one movable, with a simulated monolith joint between the blocks (Figure 8-28). The performance of waterstop repairs can be evaluated for water heads up to 76 m (250 ft) and joint movements up to 10 mm (0.4 in.). Preliminary results of current short-duration tests indicate that grouted joint repairs and most caulked joint repairs begin to leak at joint movements between 1.3 and 2.5 mm (0.05 and 0.1 in.). Catastrophic failure, generally caused by debonding of the repair material, usually occurs at a joint movement of 2.5 mm (0.1 in.) for polyurethane grouts and 5 to 10 mm (0.2 to 0.4 in.) for most joint sealants. To date, the most successful repair consisted of polyurethane grout injection of the joint combined with caulking of the upstream face. This repair exhibited no leakage for joint movements up to 5 mm (0.2 in.) and a water head of 70 m (230 ft).

Figure 8-28. Remedial waterstop test apparatus

Leakage was first observed at a joint movement of 8 mm (0.3 in.) and a water head of 38 m (125 ft); however, the magnitude of the leakage was too small to measure for water heads up to 76 m (250 ft). Additional repair materials and procedures are currently being evaluated and a REMR report will be published upon completion of these tests. In the meantime, available test results can be obtained by contacting U.S. Army Engineer Waterways Experiment Station, Structures Laboratory, Concrete Technology Division, (CEWES-SC).

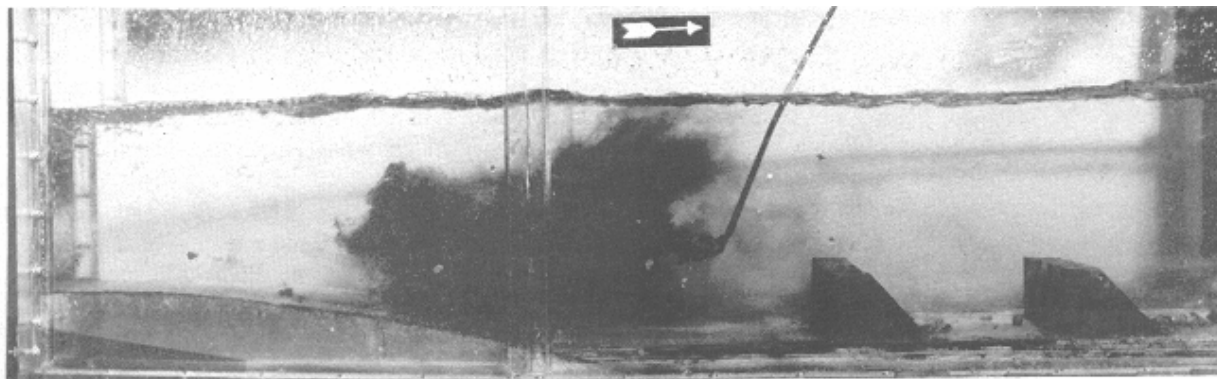
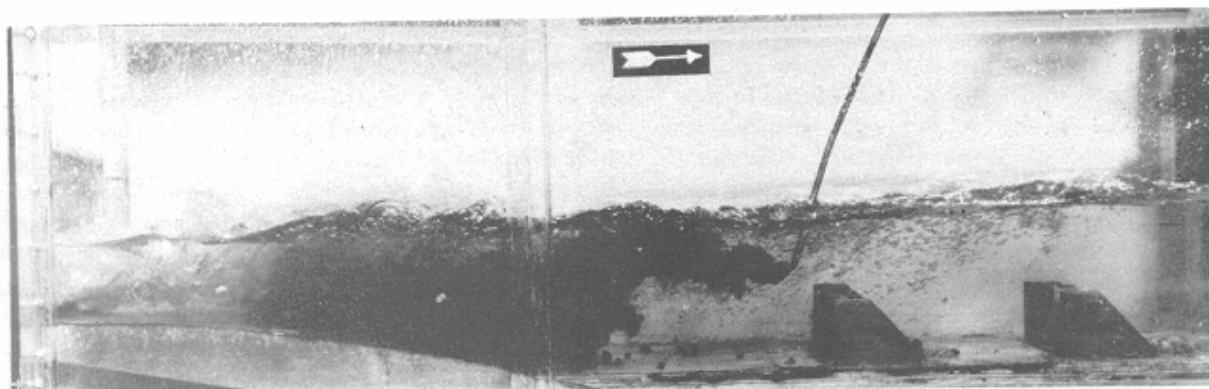
b. Pomona Dam. Prior to repair, a hydraulic model study of the existing stilling basin at Pomona Dam was conducted to investigate discharge conditions which might account for debris in the basin and to evaluate potential modifications to eliminate these conditions. Model tests (Oswalt 1971) confirmed that severe separation of flow from one side wall and eddy action strong enough to circulate stone in the model occurred within the basin for discharges and tailwaters common to the site. Photographs (Figure 8-29) of subsurface upstream flow in the right side of the basin show the results of a discharge rate of 28 cu m/sec (1,000 cu ft/sec). Based on the model

Figure 8-29. Subsurface upstream flow in the stilling basin at Pomona Dam (after Oswalt 1971)

study, it was recommended that the most practical solution was to provide a 0.9-m (3-ft)-thick overlay of the basin slab upstream of the first row of baffles; a 0.5-m (1.5-ft) overlay between the two rows of baffles; and a 1:1 sloped-face to the existing end sill. This solution provided a wearing surface for the area of greatest erosion and a depression at the downstream end of the basin for trapping debris. However, flow separation and eddy action were not eliminated by this modification. Therefore, it was recommended that a fairly large discharge sufficient to create a good hydraulic jump without eddy action be released periodically to flush debris from the basin.

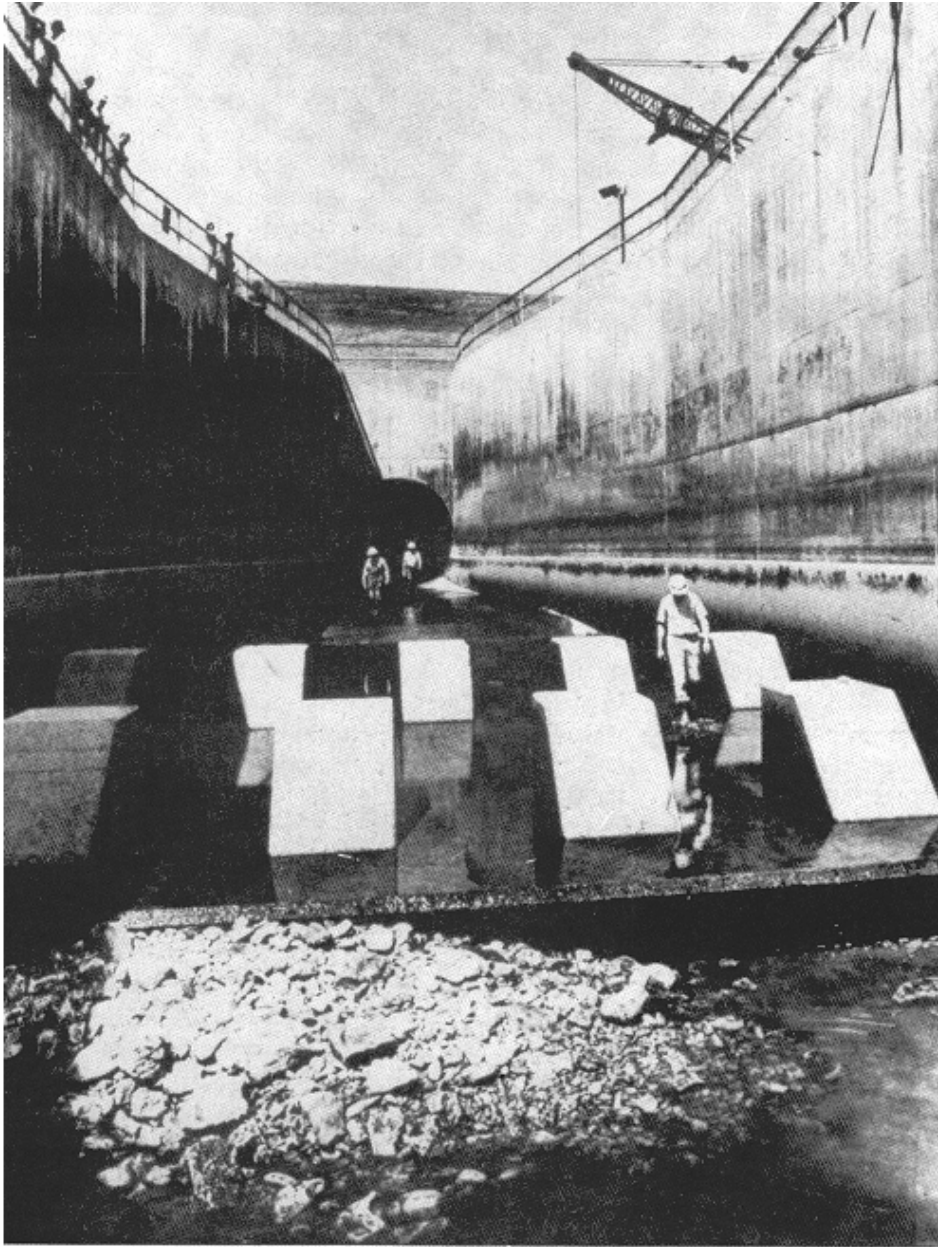
(5) The next inspection, 5 years later, indicated that the stilling basin floor remained in good condition with essentially no damage since the previous inspection. Approximately 4 cu m (5 cu yd) of debris, mostly rocks, was removed from the debris trap at the downstream end of the basin (Figure 8-30).

Figure 8-30. Stilling basin dewatered for inspection, Pomona Dam

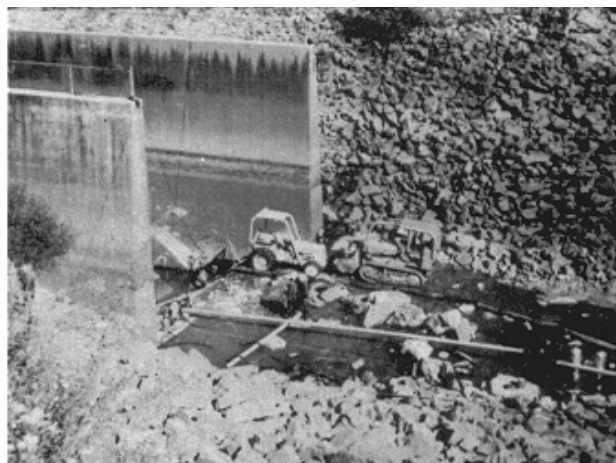
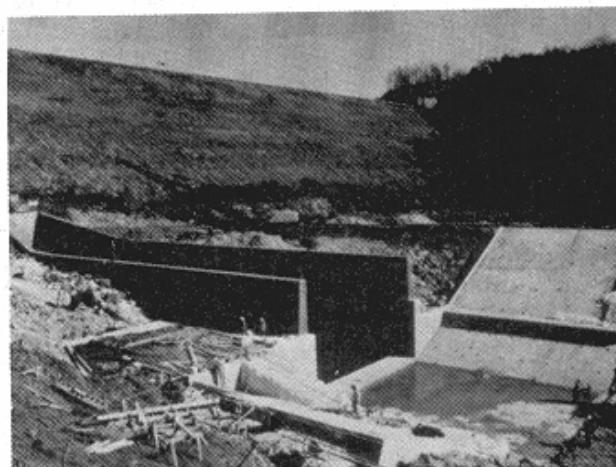
Figure 8-32. Modifications to outlet work, Nolin Dam, 1975

(1) Dewatering of the stilling basin for repair was initiated in May 1975. The structural repair work included raising the stilling basin floor elevation 228 mm (9 in.) and raising the end sill elevation 0.3 m (1 ft). Nonreinforced conventional concrete designed for 34-MPa (5,000-psi) compressive strength was used in the repair. A hydraulic model study of the existing basin was not conducted; however, the structure was modified in an attempt to minimize entry of debris into the basin. New work included adding end walls at the end of the stilling basin and a 15-m (50-ft)-long concrete paved channel section (Figure 8-32). Also, a concrete pad was constructed adjacent to the right stilling basin wall to permit a mobile crane to place a closure at the end of the stilling basin wall for more expeditious dewatering of the basin.

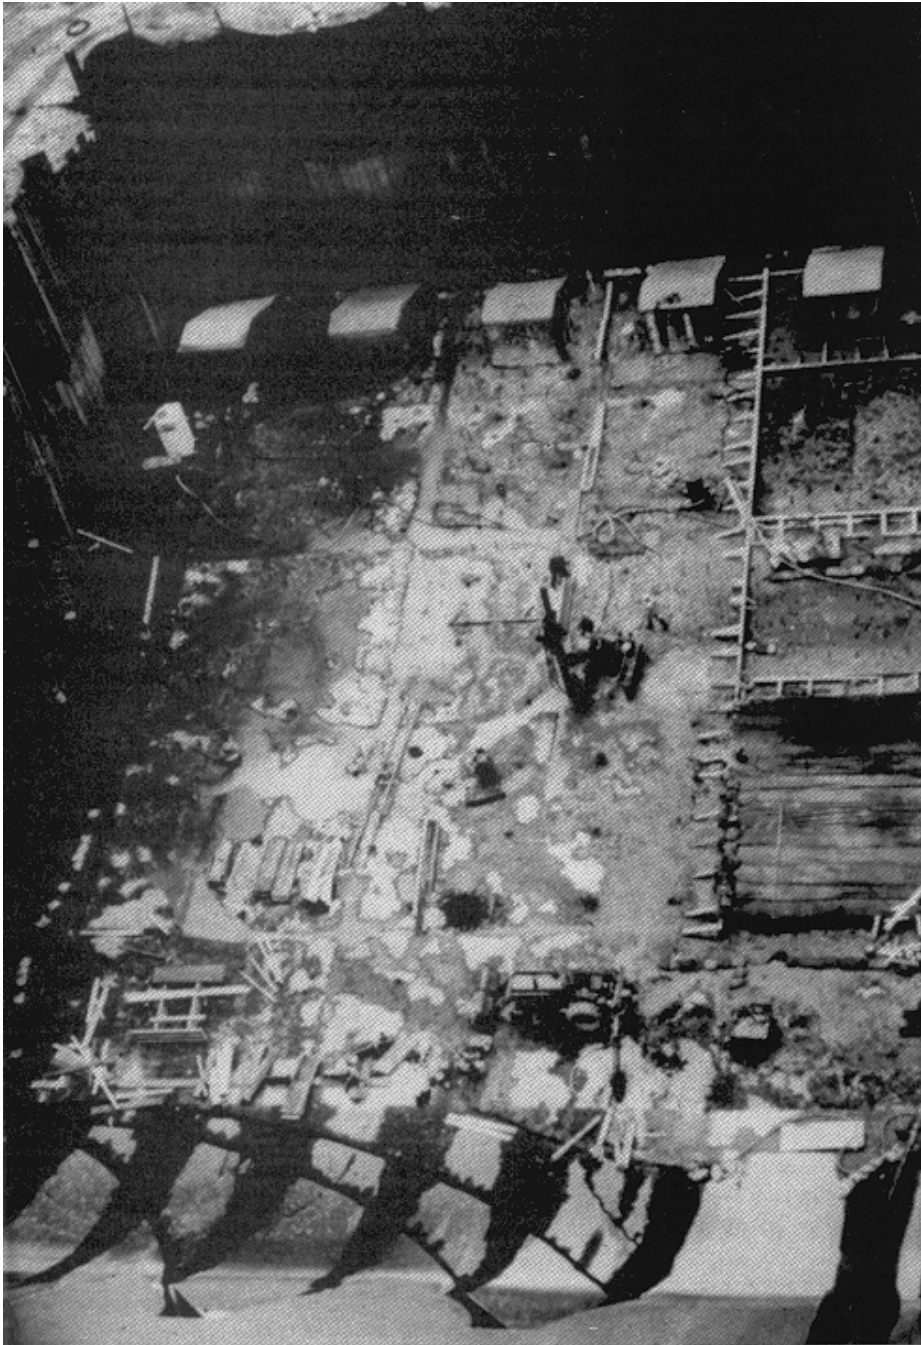
stream flow in the unobstructed part of the stilling basin. Approximately 1,070 cu m (1,400 cu yd) of fiber-reinforced concrete was required to overlay the basin floor (Figure 8-34). A concrete mixture containing 25-mm (1-in.) steel fibers, proportioned for 8 and 41 MPa (1,100 and 6,000 psi) flexural and compressive strengths, respectively, was used for the anchored and bonded overlay. The overlay was placed to an elevation 0.3 m (1 ft) higher than the original floor from the toe of the dam to a point near the baffles.

Figure 8-34. General view of repair operations, Kinzua Dam, 1974

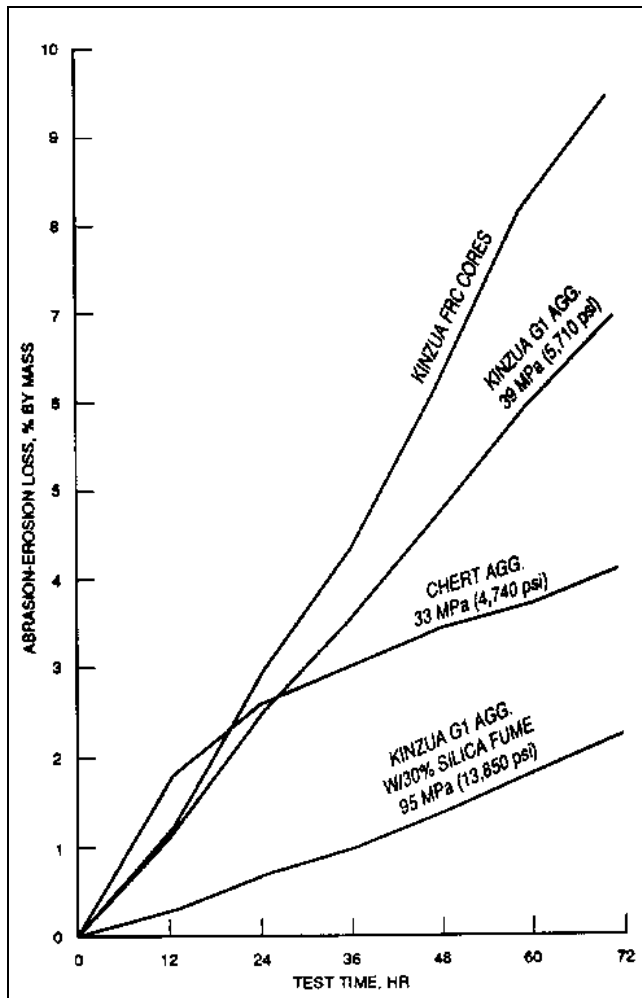
(4) A materials investigation was initiated prior to the second repair to evaluate the abrasion-erosion resistance of potential repair materials (Holland 1983, 1986). Test results indicated that the erosion resistance of conventional concrete containing a locally available limestone aggregate was not acceptable. However, concrete containing this same aggregate with the addition of silica fume and an HRWRA exhibited high-compressive strengths and very good abrasion-erosion resistance (Figure 8-35). The poor performance of fiber-reinforced concrete cores taken from the original overlay correlates well with the poor performance of the material in the actual structure.

Figure 8-35. Results of selected abrasion-erosion tests, Kinzua Dam
